# Manhole Inspection Summary

Manhole # S13AA\_008MH

Insp Date: **11/12/07 12:51 PM**

**Location** Address: **2877 POPLAR GROVE ST**

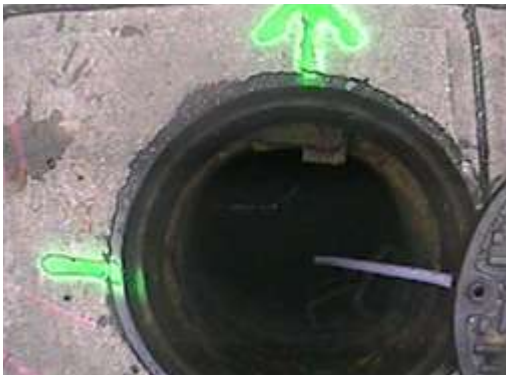
Offset: **2** (in.)

FRAME OFFSET.

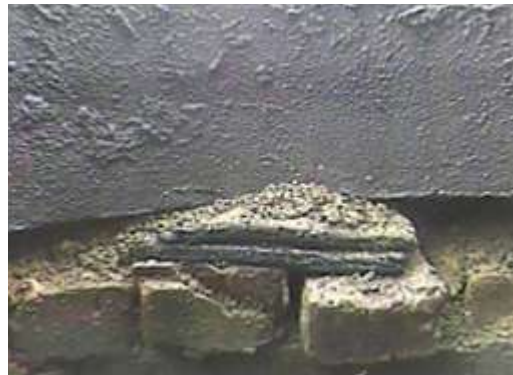
Defect 2

Condition: ☐ Sound ☒ **Cracked** ☐ Root Intrusion ☒ **Loose Brick** ☐ Deteriorated

CRACKED CHIMNEY AND LOOSE BRICKS.

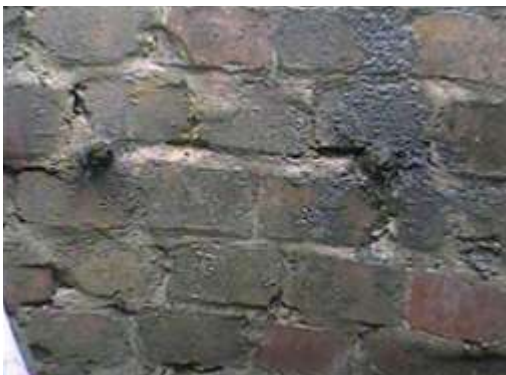
Defect 1

Count: **6** Missing: **1** ☒ **Corroded**

CORRODED STEPS

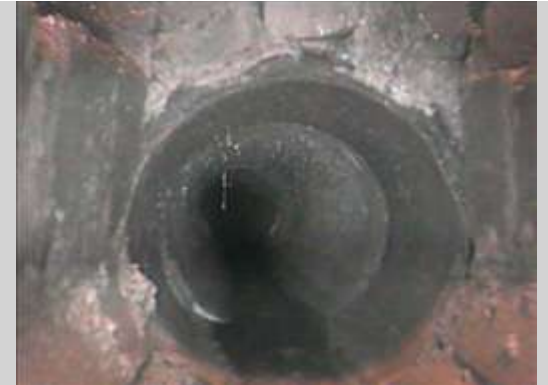
12 O'Clock Outflow

8 in. Circular Gravity Sewer  
Pipe Out @ 12 O'Clock

Infiltration: **None** Pipe Seal Cond: **Sound**

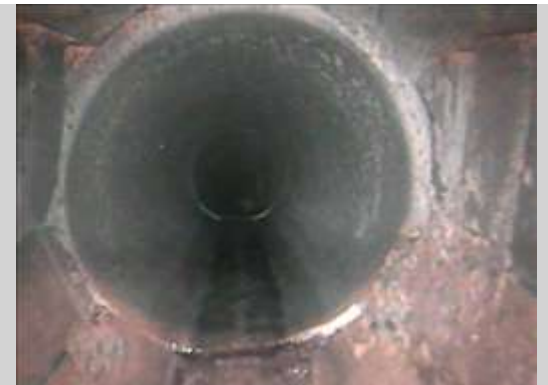
9 O'Clock Inflow

8 in. Circular Gravity Sewer  
Pipe In @ 9 O'Clock

Infiltration: **None** Pipe Seal Cond: **Sound**
